## A Study on Methodological Problems in Conservation of 'Shantinath Temple' at Khajuraho through Living Heritage Perspective

**Rakesh Mandal**

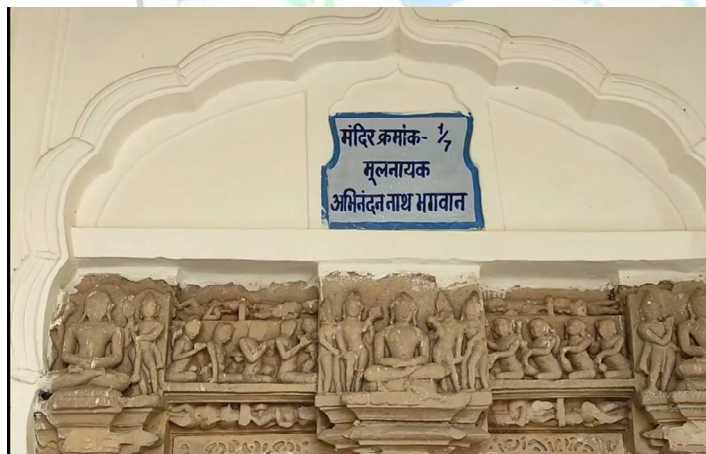
Figure-3 Inside wall of Shantinath temple showing over painted on carvings (Source- author)

- The Khajuraho temples are mainly famous for its' delicately carvings on the temple walls and structure of the temples. Temples have rich display of intricately carved designs on the walls and have distinct brownish colour which is natural colour-built materials. In Shantinath temple the outer colour of the temple complex is newly painted and the distinct colour maintaining is being done by the temple authority time to time. Although it is natural to do so as it is reconstructed because of the destruction of initial structure during the historical event of invasion. Because of the newly done colour several areas such as walls, pillars inside the temple found splashed over due to lack of care (Figure-3). The pillars and the walls were a part of the initial structure before the destruction having the same carved structure and shapes as the other Khajuraho temples of other complexes. Here also come the issue of authenticity during conservation. Due to lack of care the remaining of excavated parts of temple being affected overtime.

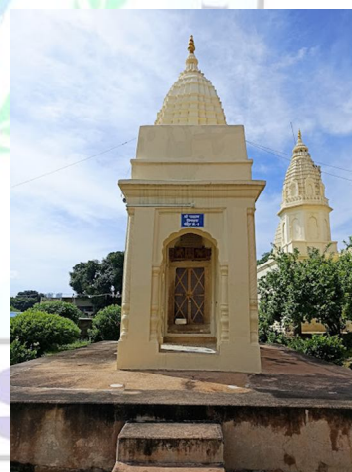
Figure-4 Padmapram temple No.2 remains closed for visitors (Source- author)

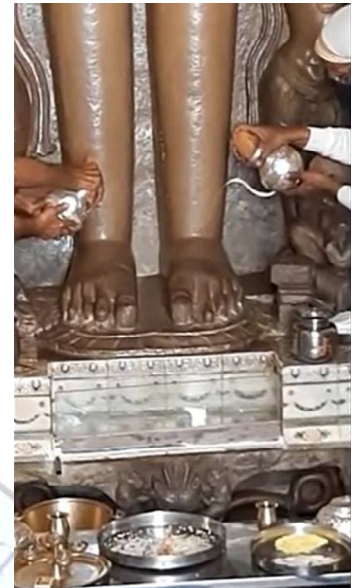
Figure-5 Pouring water on the feet of the idol (Source-Youtube)

- In this temple the exquisite 14 feet standing statue of 16<sup>th</sup> Jain Tirthankar is older than the whole building structure. Prayers and chants done here on regular basis by the priests and holy water is being poured on the feet of the idol during the ritual. At a certain height if on a regular basis on stone surface water being poured on droplet form it damages the surface.

Being nearly 1000 years old the idol of the temple is affecting by this kind of daily practice. It also might not seem serious in naked eye but this water pouring mechanism may be harmful for the stone sculpture in a broader sense (Figure-5).
